APPENDIX C. Resource Forms

KENTUCKY HISTORIC RESOURCES
INDIVIDUAL SURVEY FORM
(KHC 91-1)

1. NAME OF RESOURCE (how determined): 1/
Kennedy - Rivard Homestead

Short Biographies
of the
Kennedy and Rivard Families
and the
Kennedy - Rivard Homestead
50 Rivard Drive
Ft. Wright, Ky.
by
Steve Roth
October, 1995

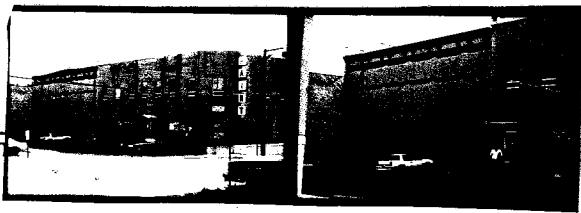
14. History:
 Although greatly altered, it appears that this structure was originally part of the Bavarian Brewing Co. It was the first known structure built and used by Bavarian as shown on the 1877 Atlas of Covington. On the 1886 Sanborn map it was shown as the office and malt house in the expanded brewery complex. In 1894 this building was labeled primarily as the "Malt Floors" and had been significantly expanded south towards Twelfth Street. On the 1909 Sanborn map this portion was used by Bavarian primarily for office space plus a storage space. It has been separately owned by Boehmer Decorating Center since 1987.

The rear portion of this structure is five bays wide and three stories tall. It is of brick construction and sits on a stone foundation. Although it has been significantly altered by filling in all the windows and doors with concrete block there is still visible evidence of the original configuration. On the first floor are four arched windows with stone sills and one arched doorway with a keystone. A row of star tie rods separate the first floor from the second. The second floor contains five identical arched windows. There is a solid brick stringcourse with arches across the top of each window and brick corbelling between them. The third story is made of smaller windows with the same form of stringcourse serving as lintels as on the second floor. The roof of the structure is a low gable with a parapet wall on each gable end. The cornice is made of paired brackets framing each bay.

Connected to this structure is a structure with a mid-nineteenth century facade. Through research it is evident that this is an alteration of the original building. Visually the foundation on the original structure is visible on Pike Street plus the canted corner was part of the original form.
